PHASE II ENVIRONMENTAL SITE ASSESSMENT

No Name Gas

625 Hilliard Rome Rd, Columbus, Ohio

Report Date: 2022-12-08

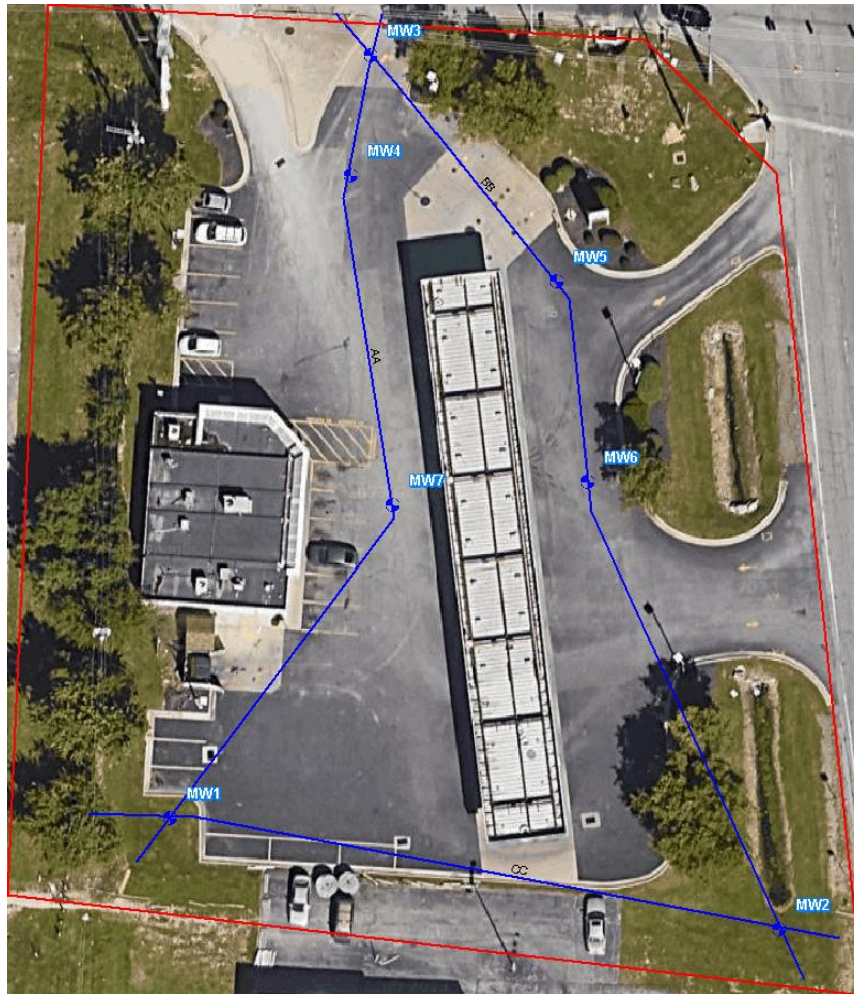
A site location map is included in Figure 1.

The sampling plan consisted of soil and/or groundwater samples collected from test pits and/or borings as shown in Figure 1 and described in sections 4.2 and 4.3 of this report.

A total of 7 borings were drilled at the approximate locations shown on Figure 1. The locations, depths, and dates of the borings are provided in the Tables section at the end of this report. The soil samples were collected from the borings using a split-spoon sampler.

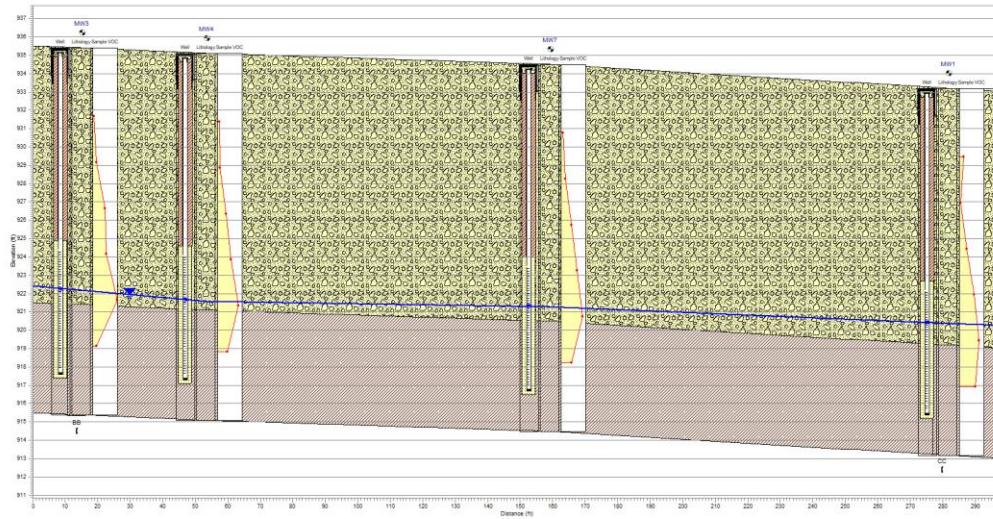
Figure 4: Cross-section AA

The stratigraphy encountered during this assessment consisted of 10 to 15 feet of sand gravel then clay. The stratigraphic information recorded during the investigation is presented on the test pit and boring records in Appendix X1.

Cross-sections showing the contaminant distribution, stratigraphy, and water table are provided in Figures 4, 5, and 6 at the end of this report.
