PHASE I ENVIRONMENTAL SITE ASSESSMENT

No Name Gas
2911 Barton St. S, Hamilton, Ontario

Report Date: 2022-12-20
Project Number: PN12345

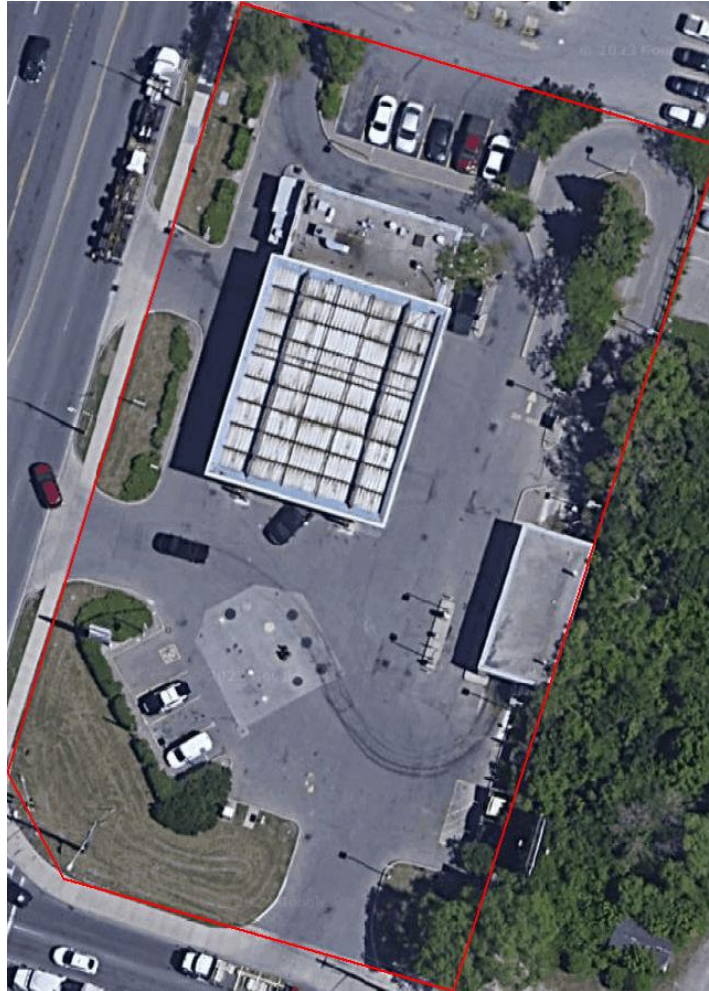
Phase One Site Plan

The following areas of potential contamination were identified on the subject property and are shown in the figure in Appendix 1:

- Documented and reported petroleum leak during piping upgrade.

It is unclear whether the cleanup after the petroleum leak removed all contaminated soil.

- A Phase II ESA is recommended to determine if there is any impacted soil and groundwater in the area of the reported petroleum leak.

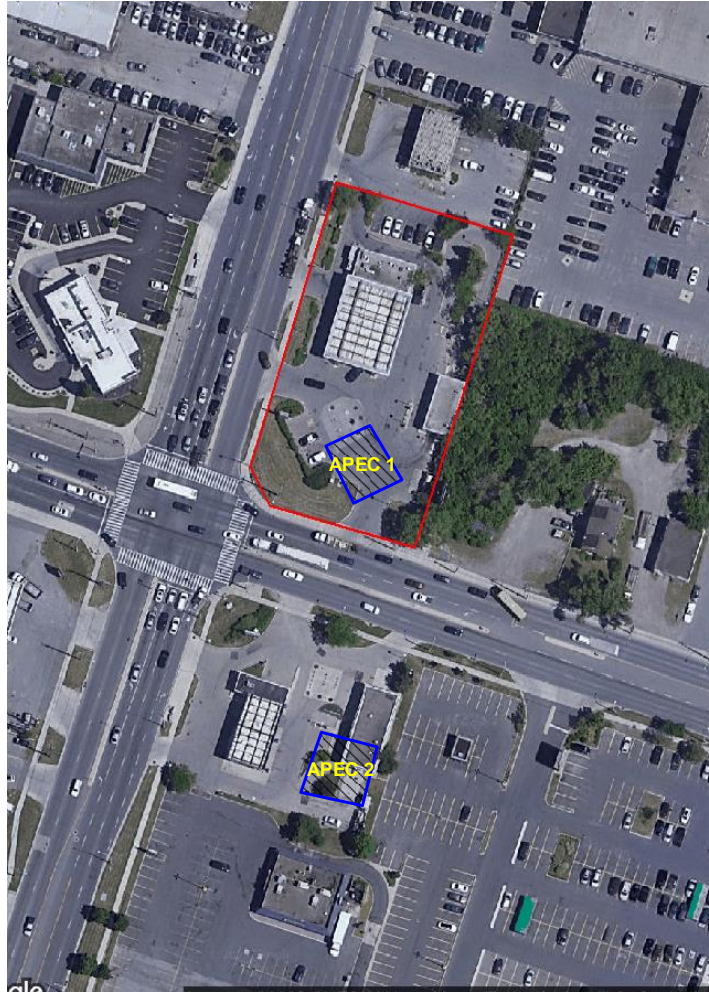
Areas of Potential Environmental Concern

It is our opinion that this potential contamination represents a significant environmental concern. The petroleum leak could have impacted surrounding soil and potentially the groundwater.

APEC 1: USTs On-site
 APEC 2: USTs Off-site

- A Phase II ESA is recommended to determine if there is any impacted soil and groundwater in the area of the reported petroleum leak.

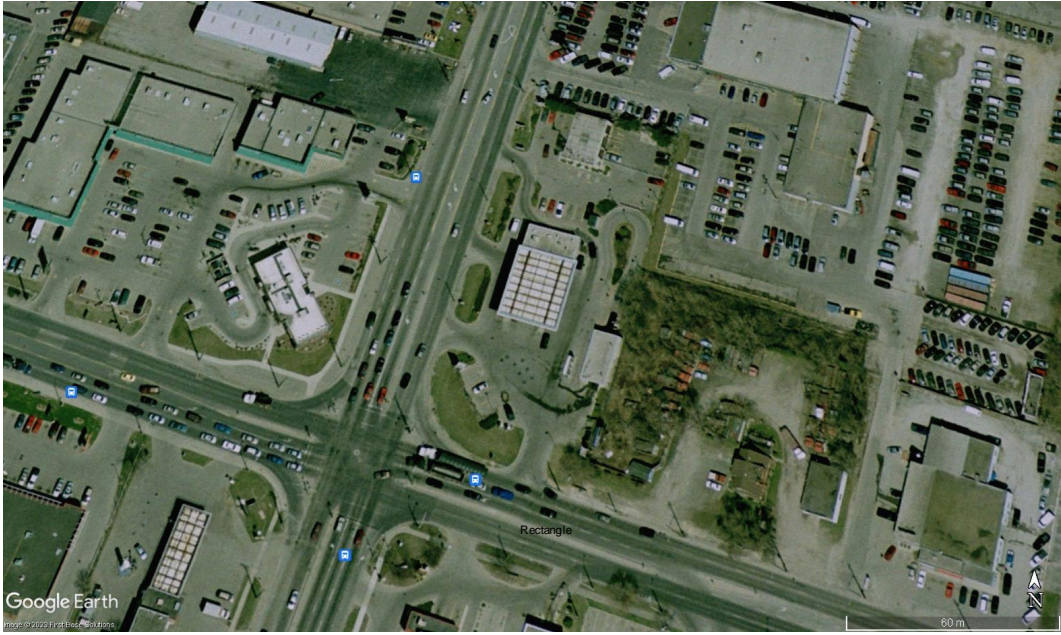
2005 Historical Satellite Image
Project Number: CAD EX Project Name: Canadian Examples Client Name: ACME Oil & Gas
Site Location Address: 2911 Barton St S City: Hamilton State: ON
Project Manager: John Smith Date: 2023-1-24
